**2007 Operations, Maintenance,
and Monitoring Report**

**Mandalay Bank Protection
Demonstration**

State Project Number TE-41
Priority Project List 9

August 2007
Terrebonne Parish

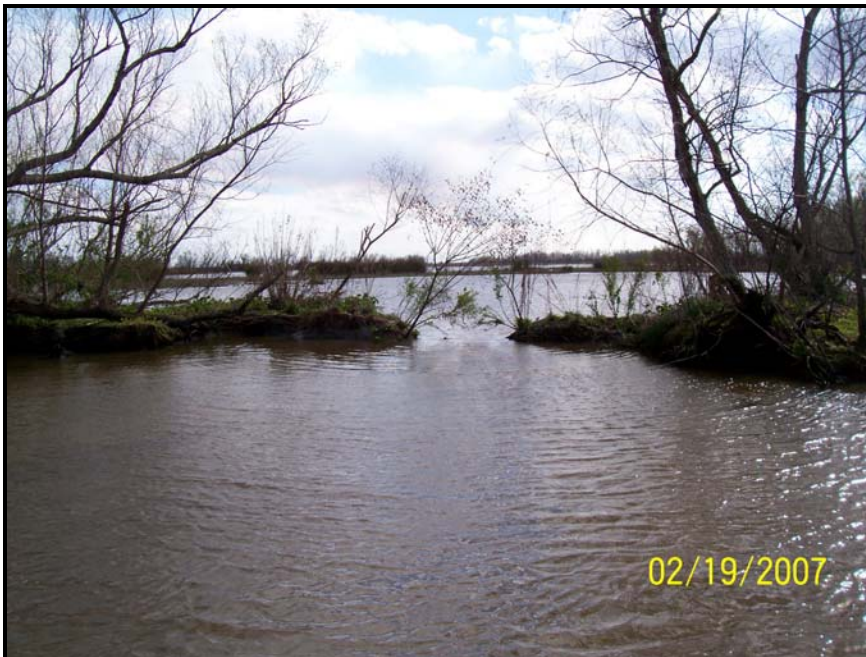
has now been breached leaving the bank open again (Appendix B, Photo 6). This bank line breach should be noted in the demonstration project results.

Photo 6. *Site R1 –
View of re-opened
breach in bank
(dredged material
placed during
construction) east of R1
looking south from
GIWW.*

Maintenance needs identified were the leaning warning sign at Site F2, the damaged fence sections at Site F2, and the breach east of Site R1. No maintenance funds are provided for the repair of project features; therefore, the timber fence and bank line breach will not be repaired but should be noted in the demonstration project results. The warning sign at Site F2 is not deemed an emergency repair need since the fence structures are located immediately adjacent to the bank of the GIWW and do not pose a hazard to navigation. However, repairs to the leaning support pile may be attempted by the Thibodaux Field Office.

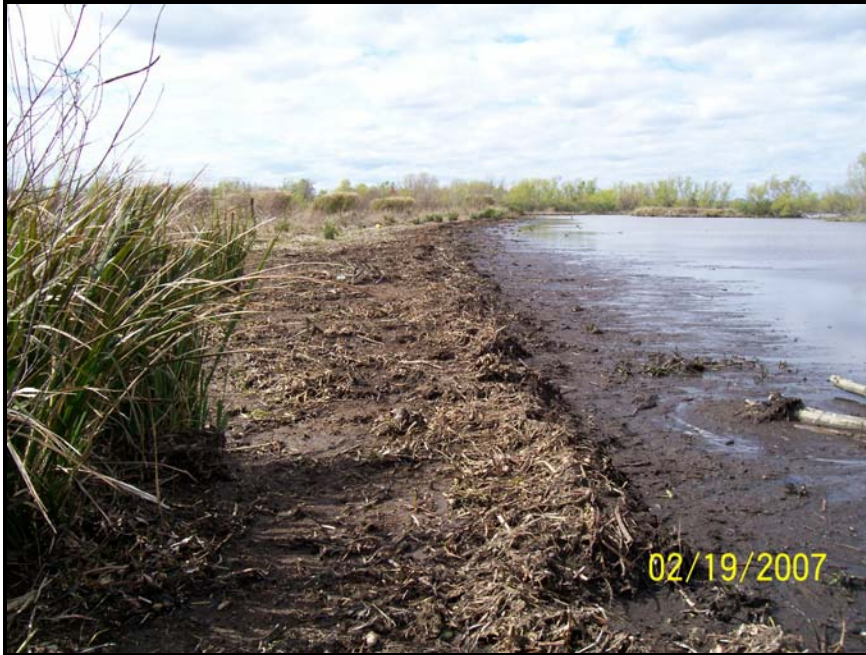
At the adjacent Sites J1 and J2, accretion has occurred, and the A-Jacks® (double row) are now covered by well-vegetated, accumulated material. The depth of cover over the A-Jacks® was found to be 1 ft to 2 ft in some locations. The extent of vegetated accretion appears to be greater than 200 ft in some locations as it extends from the old shoreline behind the A-Jacks® northward toward the GIWW beyond the warning signs at the two sites. Survival of the plantings at J1 and J2 appears to be significantly less than was observed during the 2005 inspection. Some groups were noted that may still be dormant from the winter. Also, it appears that some plantings have been transplanted, possibly by the hurricanes of 2005. At Site J3, the water level was just below the tops of the A-Jacks®. No accretion has occurred except at the west tie-in where the structure ties into the Site A2 plug. In fact, it appears as if the shoreline may have continued to experience some measure of erosion at this site. The survival rate of the plantings at Site J3 still appears to be the lowest (out of the three sites) as noted in the 2005 inspection report. The tie-ins appeared to be in good condition at the three sites. The warning signs and support piles at the three sites were in excellent condition. No maintenance is recommended for the concrete armor unit sites at this time (Appendix B, Photos 31 – 41).

Photo 31. *Site J1 – View of accretion and vegetation in front of warning sign looking west.*

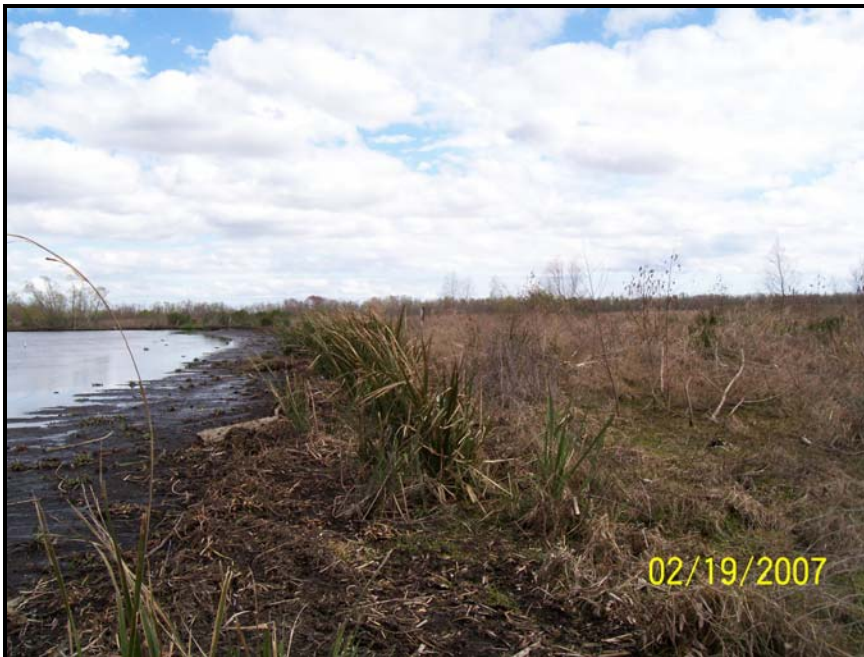
Photo 36. Site J2 –
View of accretion and
vegetation in front of
warning sign looking
east.

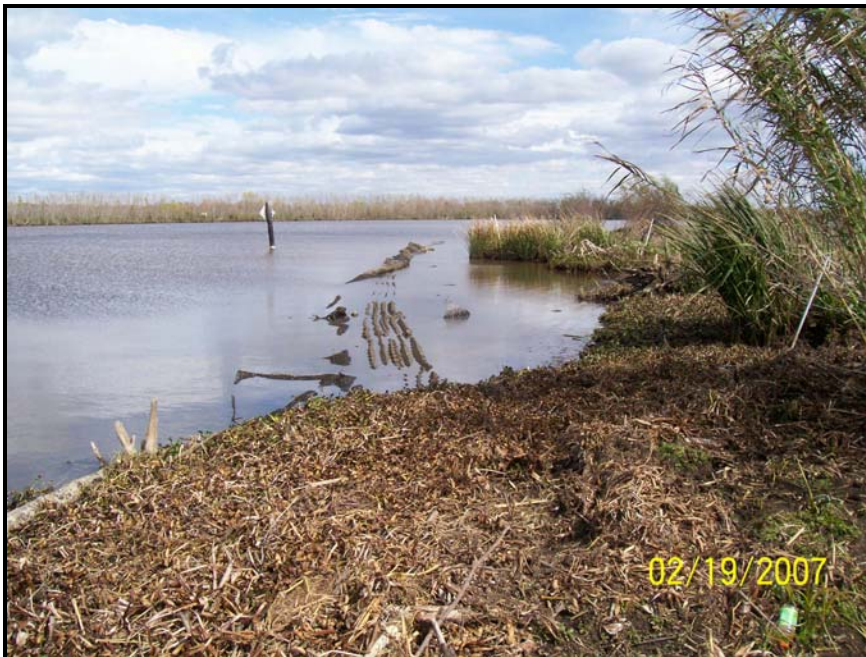
Photo 38. *Site J3 –
View of west bank tie-in
(covered by accreted
material).*

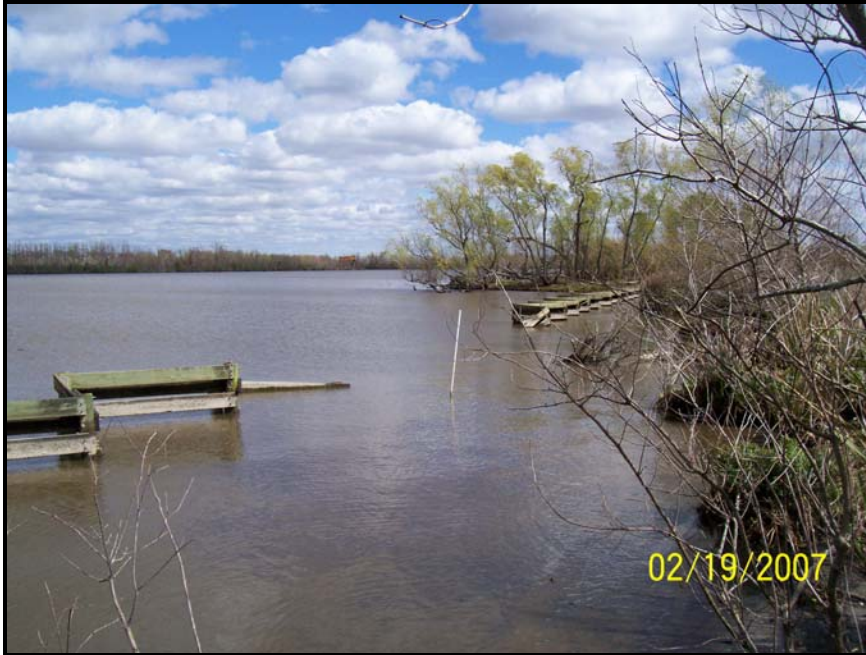
In general, the timber fencing and galvanized hardware at the three sites appeared to be in good condition with no signs of damage. One location of damage was noted however. At Site F2, approximately seven or eight fence spans were missing near the middle of the structure. It appears as if a barge struck the fence here. From communication with field personnel, it is believed this occurred in early May 2006. Most of the bank tie-ins were in good condition. The bank has eroded approximately 2 ft away from the west end of the fence at Site F2. The warning signs and support piles were in excellent condition at Sites F1 and F3. The warning sign support pile at Site F2 was struck by the barge as well and is now leaning with the sign partially submerged. At Site F3, significant accretion has occurred.

Photo 47. Site F2 –
View of damage to
timber fencing looking
northeast.

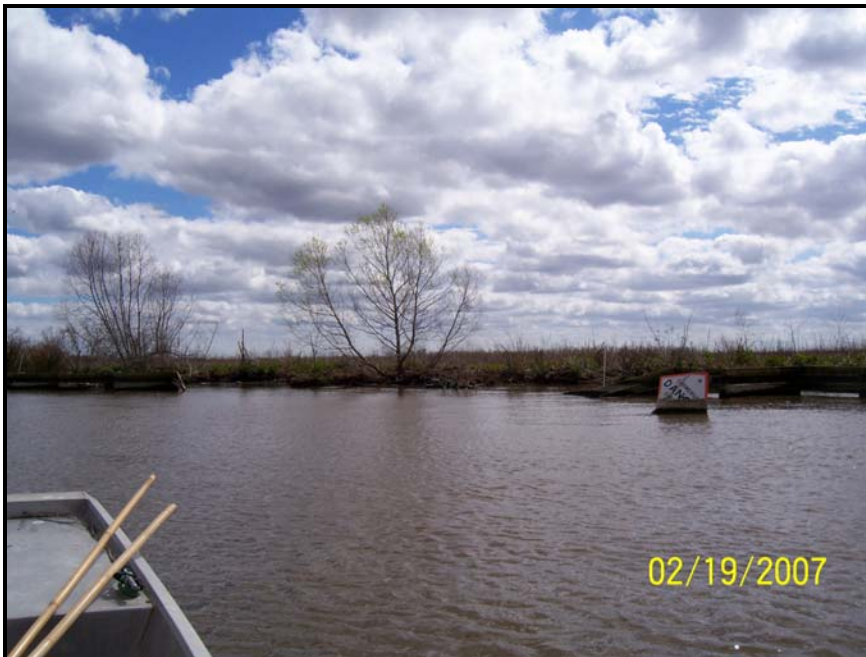
Photo 48. Site F2 –
View of damage to
warning sign and
fencing looking south.

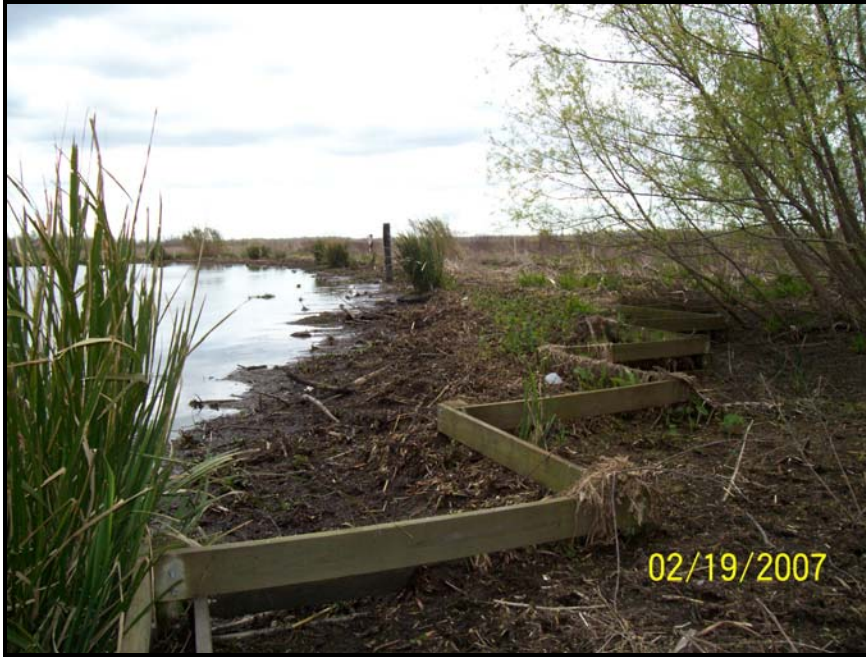
This fence site is adjacent to plug Site A2 where extensive accretion of material has occurred. In some locations material has accreted greater than 50 ft from the old shoreline behind the fence out to the warning sign. In the vertical direction the material has reached the second timber on the fence or higher. The plantings' survival rate at Site F3 appears to have drastically reduced from that noted in the 2005 inspection. As noted in the 2005 inspection, the survival rates of the planted giant cutgrass associated with Sites F1 and F2 appeared to still be very low. At Site F2, the identified maintenance needs were the leaning warning sign at Site F2 and the damaged fence sections. No maintenance funds are provided for the repair of any project features, so no maintenance will be performed on the fence. However, the damage to these sections as well as the length of time since the occurrence should be noted in the demonstration project results (Appendix B, Photos 42 – 54).

Photo 51. *Site F3 –
View of timber fencing,
plantings, and accreted
material looking
southeast.*
